NDI ID PA 00604
PA DER 45-238

SINCAVAGE LUMBER COMPANY DAM (LAKE SINCA DAM)

PHASE I INSPECTION REPORT NATIONAL DAM INSPECTION PROGRAM

AUGUST 1981

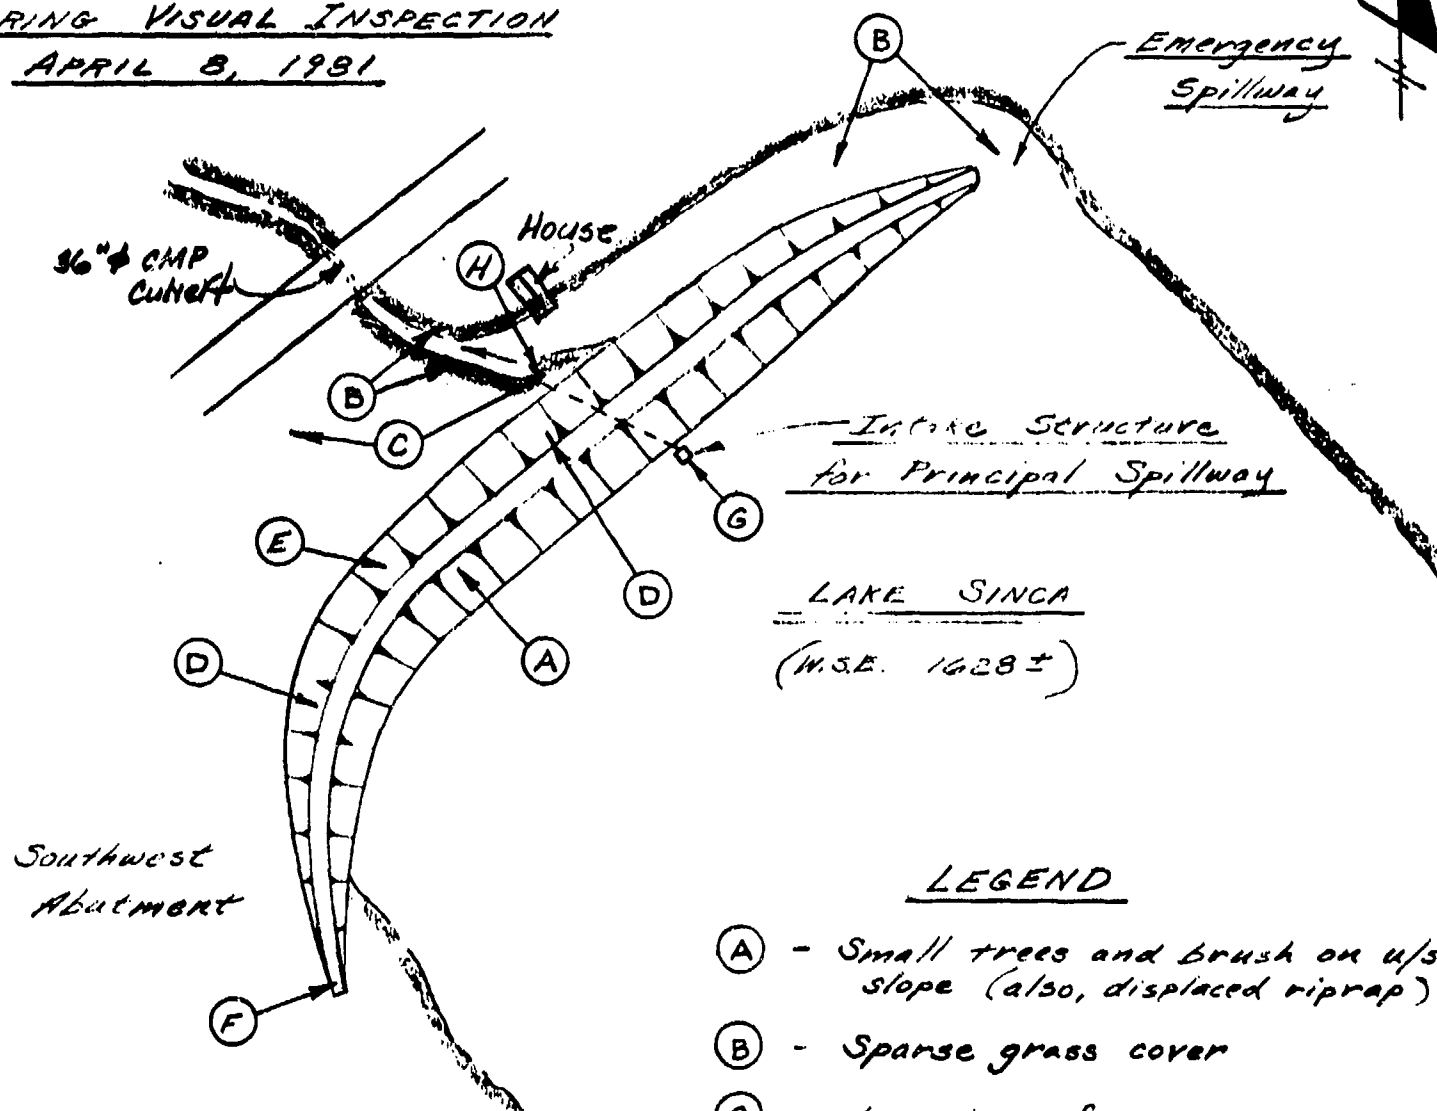
LOCATION PLAN OF
DEFICIENCIES OBSERVED
DURING VISUAL INSPECTION
APRIL 8, 1981

- (A) - Small trees and brush on u/s slope (also, displaced riprap)
- (B) - Sparse grass cover
- (C) - Location of seepage
- (D) - Sloughing of embankment
- (E) - Large stones on d/s face
- (F) - Top of dam el. below design elev. for most of dam
- (G) - No access to intake structure
- (H) - Cracking of outlet headwall

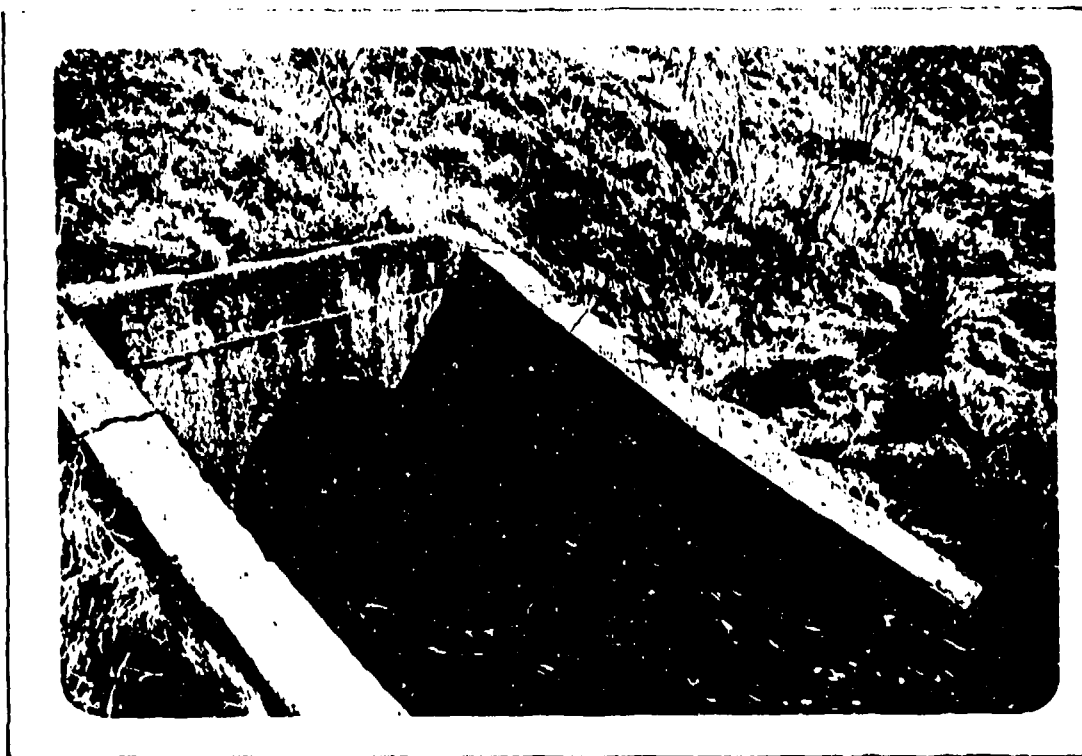
intake structure could not be inspected because access was not available. From the dam crest it appeared to be in good condition. It has a bar trash rack, consisting of 0.5 inch diameter bars, spaced four inches on center, mounted horizontally over its four-foot square opening. The outlet structure, located at the downstream toe of the dam, is in poor condition. As illustrated on photos 11 and 12 of Appendix C, each of the wingwalls is cracked near its juncture with the headwall.

The concrete outlet headwall is cracked badly at the wing walls where the toe drain pipes emerge (Photos 11 and 12, Appendix C)

11. PRINCIPAL SPILLWAY OUTLET STRUCTURE. (4/8/81)

3. The concrete outlet structure of the principal spillway should be repaired.

Repair concrete headwall
